ROOFING NO. 3017

SUBJECT: COMPARING POLYISO AND MOLDED POLYSTYRENE FROM THE PAST TO TODAY.

DATE: AUGUST 2016 (REVISED JANUARY 2019)

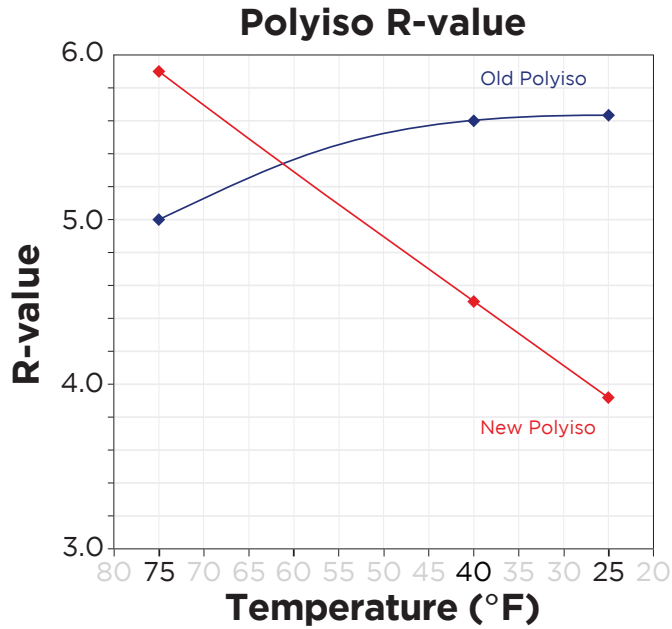
A plot of the R-value for the 17 year old polyiso and new polyiso demonstrates the dramatic change in polyiso insulation in recent years. “New” polyiso loses significant R-value at cold temperatures.

R-VALUE PER INCH ¹ FOR 17 YEAR OLD ROOF INSULATION			
Product	Temperature ²		
	75°F	40°F	25°F
Polyiso	5.0	5.6	5.7
Molded Polystyrene (Type VIII)	3.8	4.1	4.2

It is clear that the 17 year old polyiso R-value of R-5.0 at 75°F is well below the published R-value for polyiso of R-5.6. This is not surprising since polyiso insulation loses blowing agents and R-value with age. At colder temperatures, the R-value of the polyiso improved slightly.

R-VALUE PER INCH ¹ FOR “NEW” ROOF INSULATION			
Product	Temperature ²		
	75°F	40°F	25°F
Polyiso	5.8	4.5	3.9
Molded Polystyrene (Type VIII)	3.9	4.2	4.3

It is clear that the R-value of “new” polyiso of 5.8 at 75°F meets the the published R-value for polyiso of R-5.6. This is not surprising since the polyiso insulation is new and has not yet lost its blowing agents and R-value which will occur with age. At colder temperatures, the R-value of the polyiso decreased dramatically. This loss of R-value for polyiso is a known phenomenon and has been documented extensively ^{1,2}.

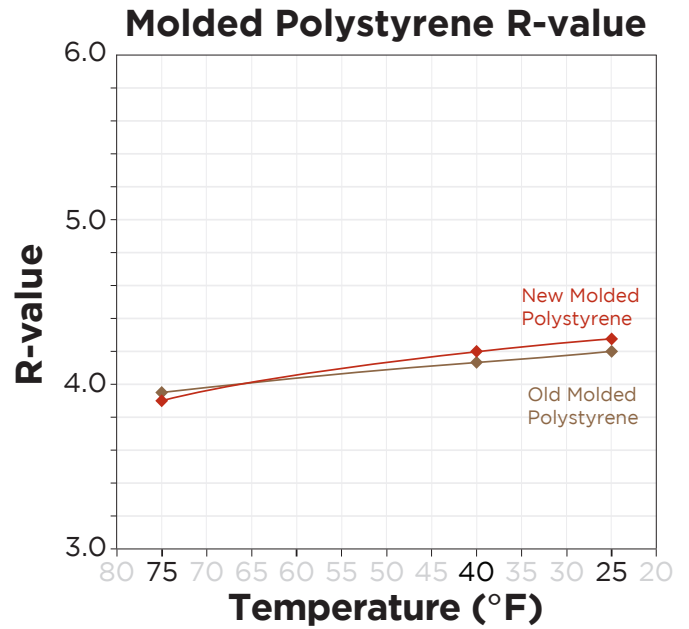
In comparison, the R-value for 17 year old molded polystyrene and new molded polystyrene are similar. This demonstrates that molded polystyrene can be trusted to have stable R-value performance.

The R-value for the 17 year old molded polystyrene at 75°F meets the published R-value of 3.8 for a Type VIII molded polystyrene product. This is not surprising since the R-value of molded polystyrene does not change with time. At colder temperatures, the R-value of the molded polystyrene increased.

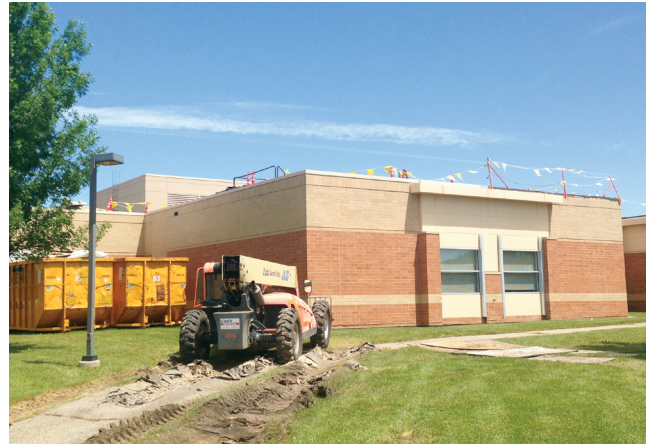
Figure 2. Roof replacement in progress

A school building located in Minnesota was undergoing a roofing system replacement in 2016 and it provided a perfect opportunity to evaluate the performance of the existing roof insulations. The school was originally built in 1999 and consisted of a combination of polyiso and molded polystyrene roof insulation. Samples of both products were removed from the roof and evaluated
